IBP REPORT

ASSESSING THE LONG-TERM PERFORMANCE OF APPLIED EXTERNAL THERMAL INSULATION COMPOSITE SYSTEMS (ETICS)

Fraunhofer Institute for Building Physics IBP

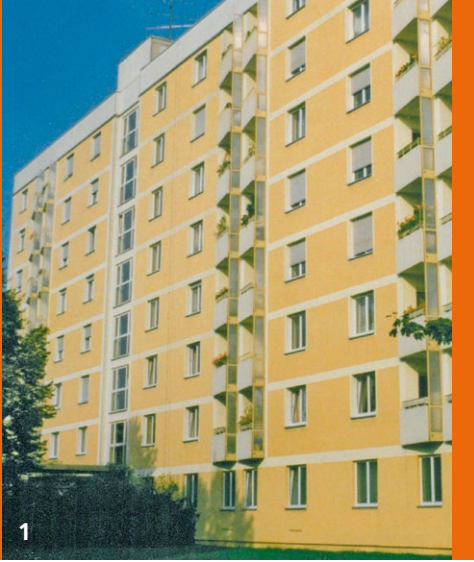
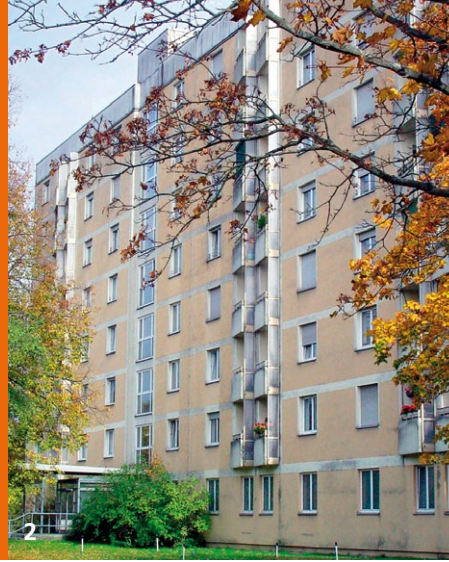
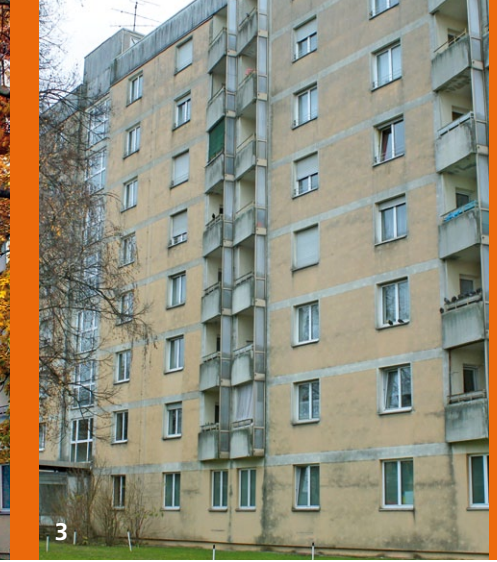
There are systems that did not receive any renovation coating during 14 up to 29 years, yet do not show any technical defects like cracks, blistering or larger areas of render detachment. A building in Munich (Fig. 1–3), which was not refurbished since the application of the mineral insulation system in the 1990s, can still be classified in category 1. However, significant grey discolorations due to soiling may occur (just like with conventionally rendered façades), and in most cases a certain extent of weathering of the paint coats can be determined. In addition, other typical phenomena may occur at ETIC systems: for instance, insulation fixings or individual panel joints can become apparent at the surface and at the building's

1–3 West façade of property no. 16 in Munich, 4 years (left), 19 years (centre) and 29 years (right) after application of the ETIC system, no intermediate renovation of the façade.

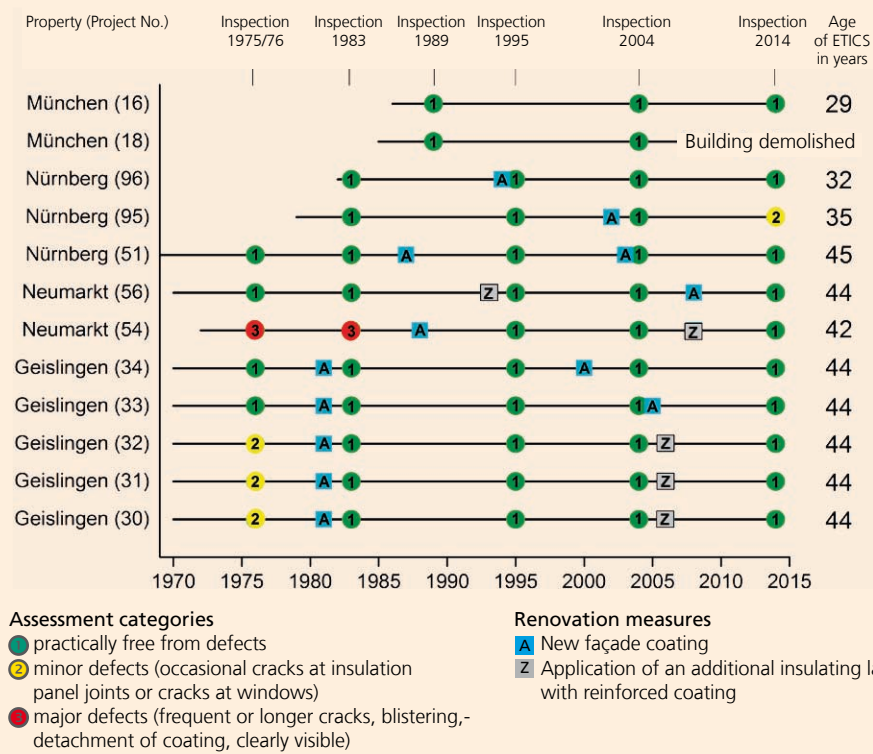
Diagram 1 Time schedule of application, on-site inspection and renovation of ETICS – including indication of the façade condition

The age of the examined ETIC systems ranges from 29 to 45 years. Within the last ten years, five buildings did not undergo any renovation. Four buildings were renovated by the installation of an additional insulation layer on their ETICS, but for no other reason than for energy retrofit. Two buildings were repainted. Following the 2014 on-site inspection, the condition of the façades of ten out of eleven buildings can be classified in category 1 “practically free from defects”. Only one façade, which had been repainted, is locally affected by minor or major defects (category 2).
